**DEVELOPMENT OF REPAIR PROCESSES  
AND SOURCES FOR B-52 AIRCRAFT  
WINDOWS/WINDSHIELDS**

**RICHARD J. OLSON**

**FEBRUARY 1996**

**TECHNICAL REPORT FOR 09/91 - 12/31/95  
CONTRACT NUMBER FO9603-90-D-2217-SD02**

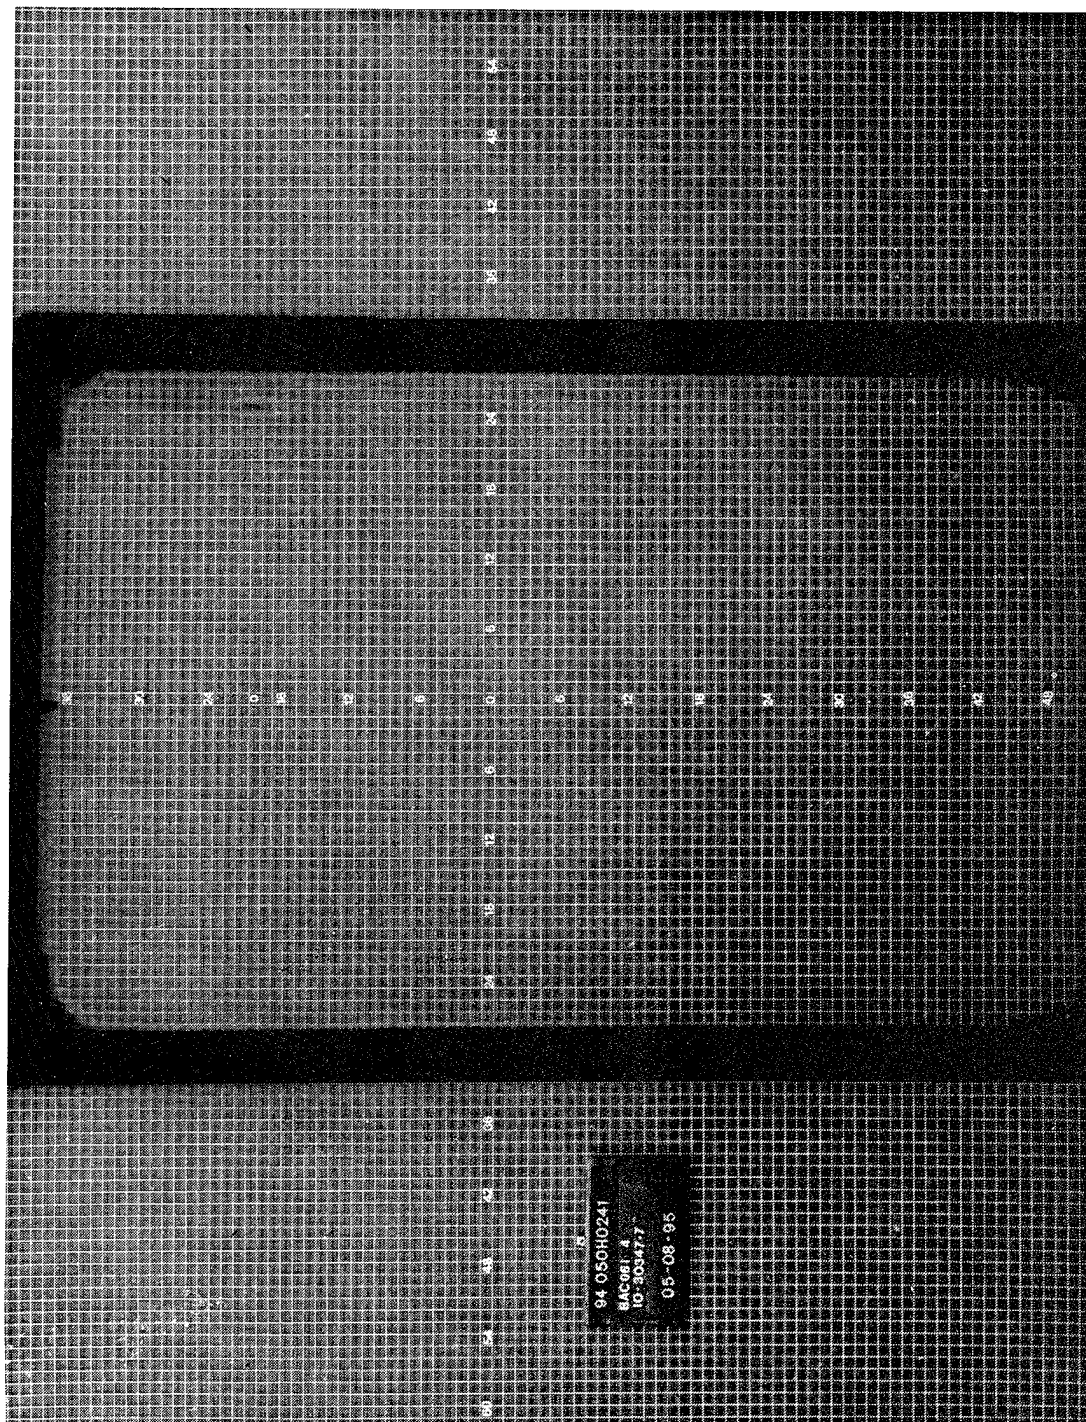
Figure 4.1 Worst B-52 #1 W/WS Optical Distortion (S/N 94-050-HO-241)

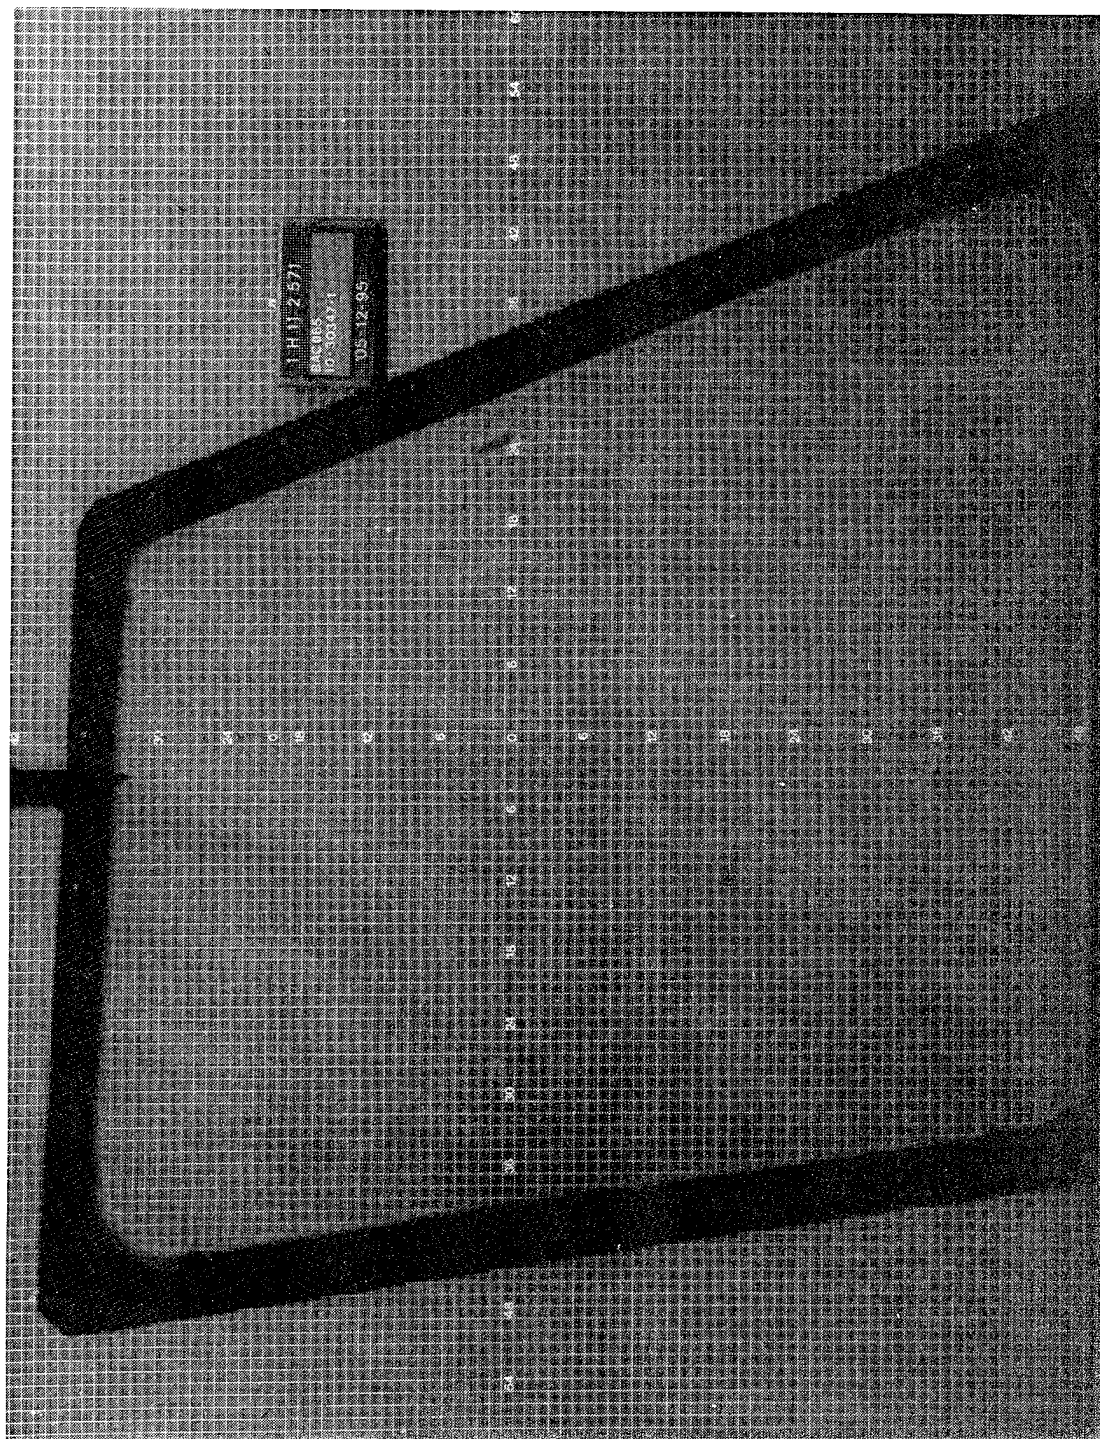
**Figure 4.2 Worst B-52 #2 W/WS Optical Distortion (S/N 1-H-11-2-571)**

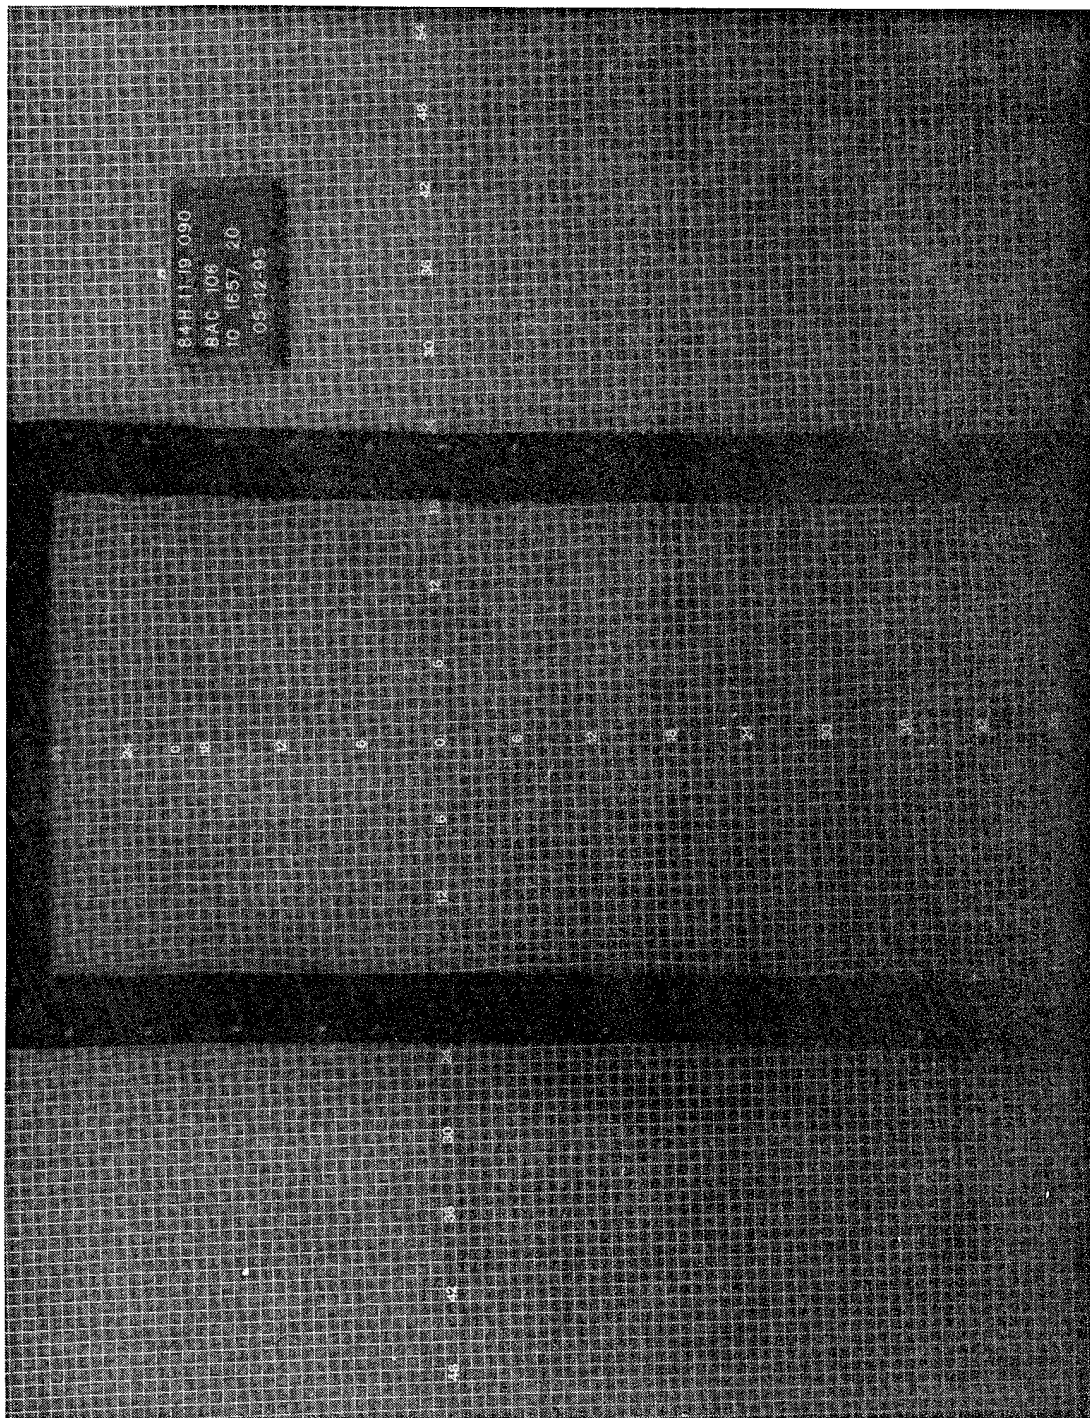
**Figure 4.3 Worst B-52 Escape Hatch Optical Distortion (S/N 84-H-11-19-090)**

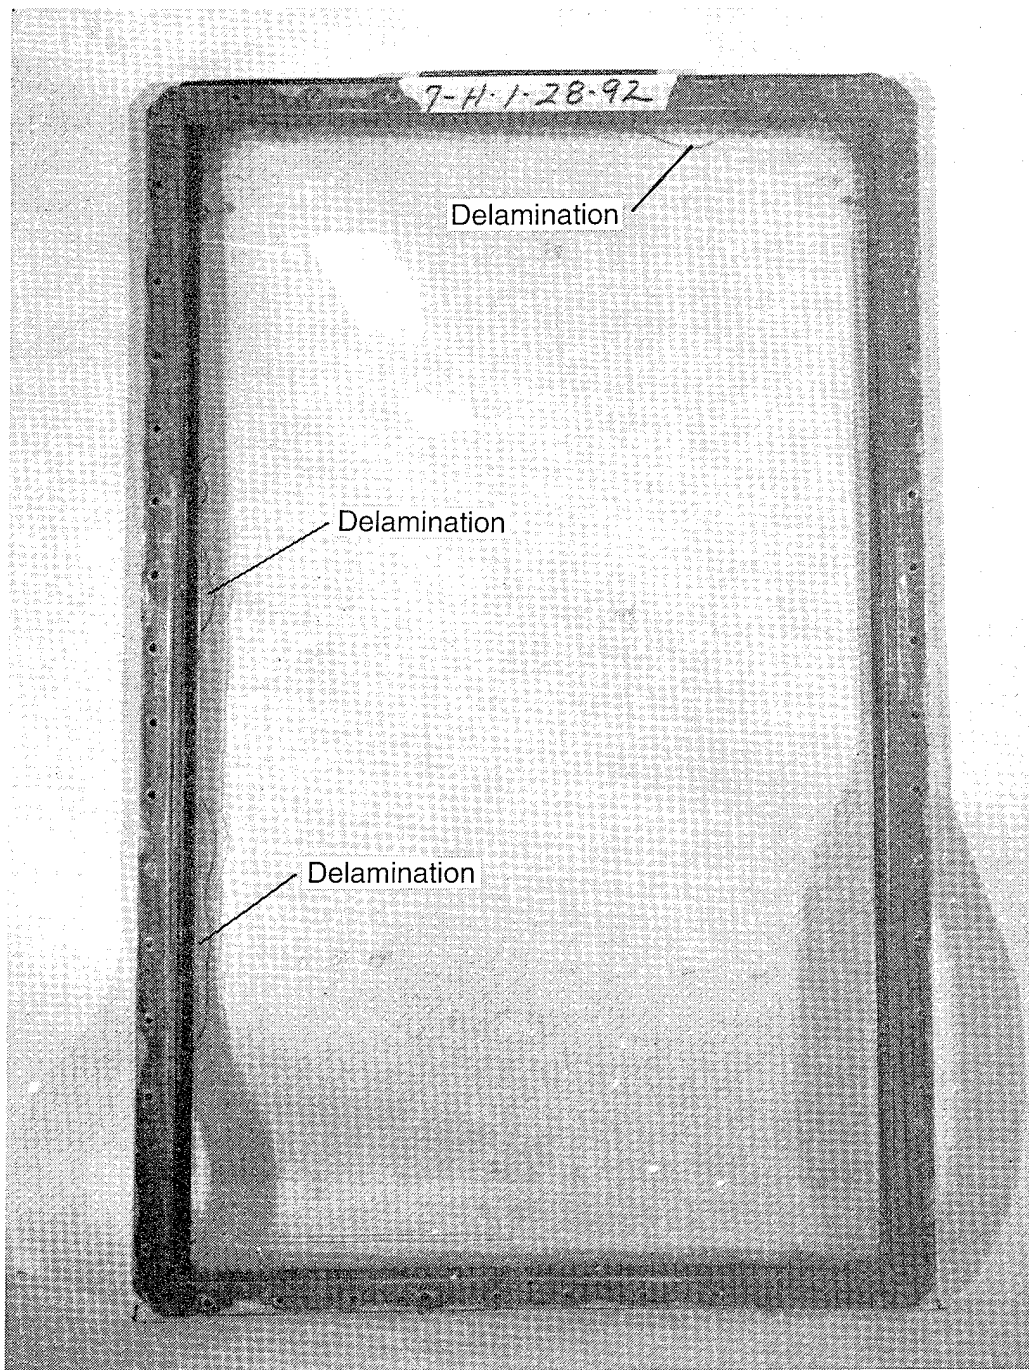
**Figure 4.6 Worst B-52 #1 W/WS Delamination (S/N 7-H-1-28-92)**

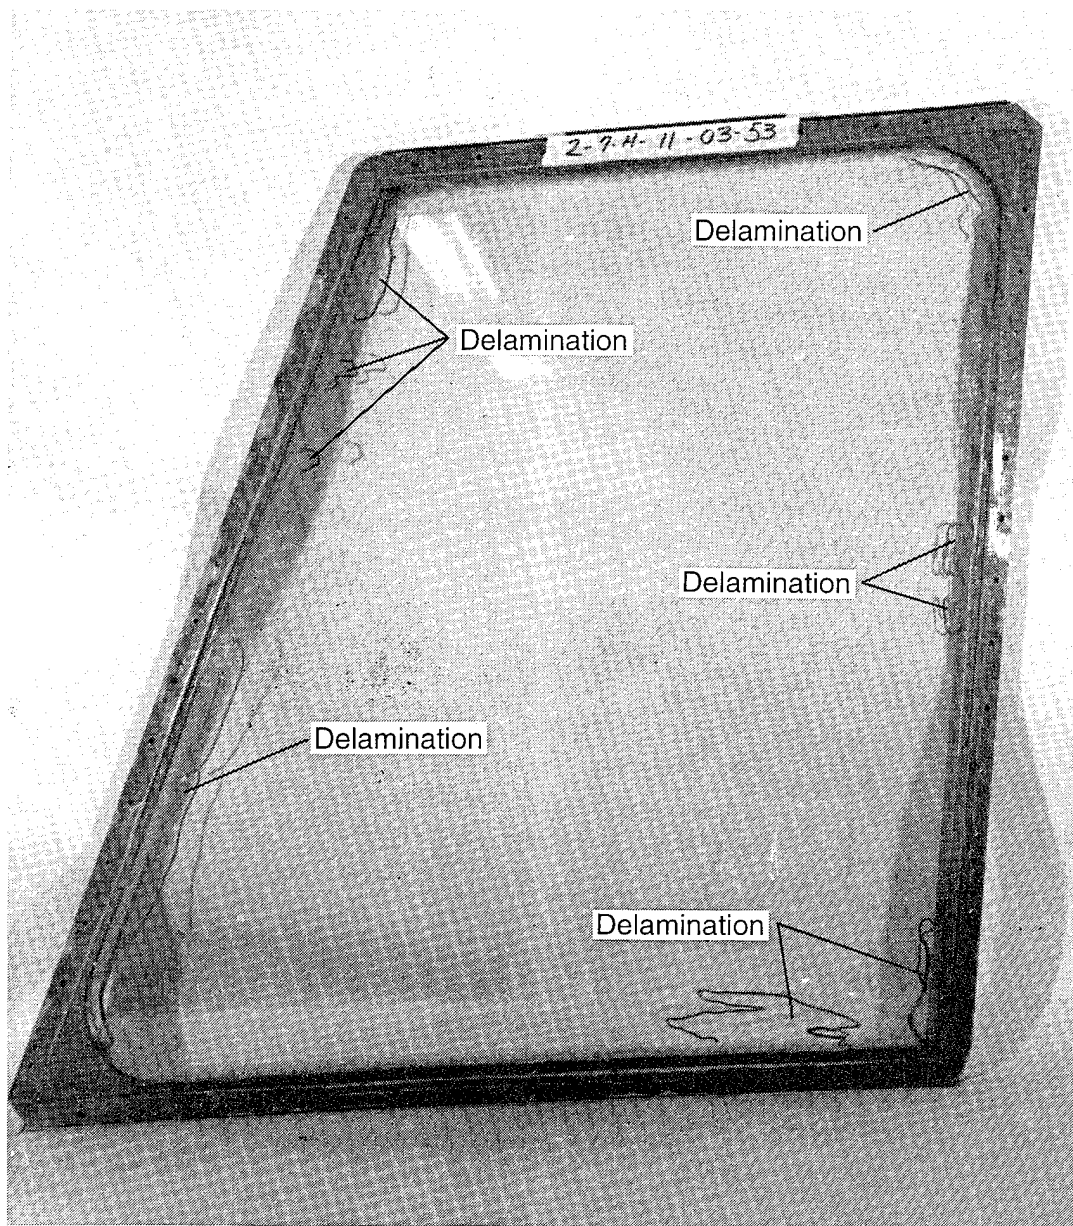
**Figure 4.7 Worst B-52 #2 W/WS Delamination (S/N 7-H-11-03-53)**

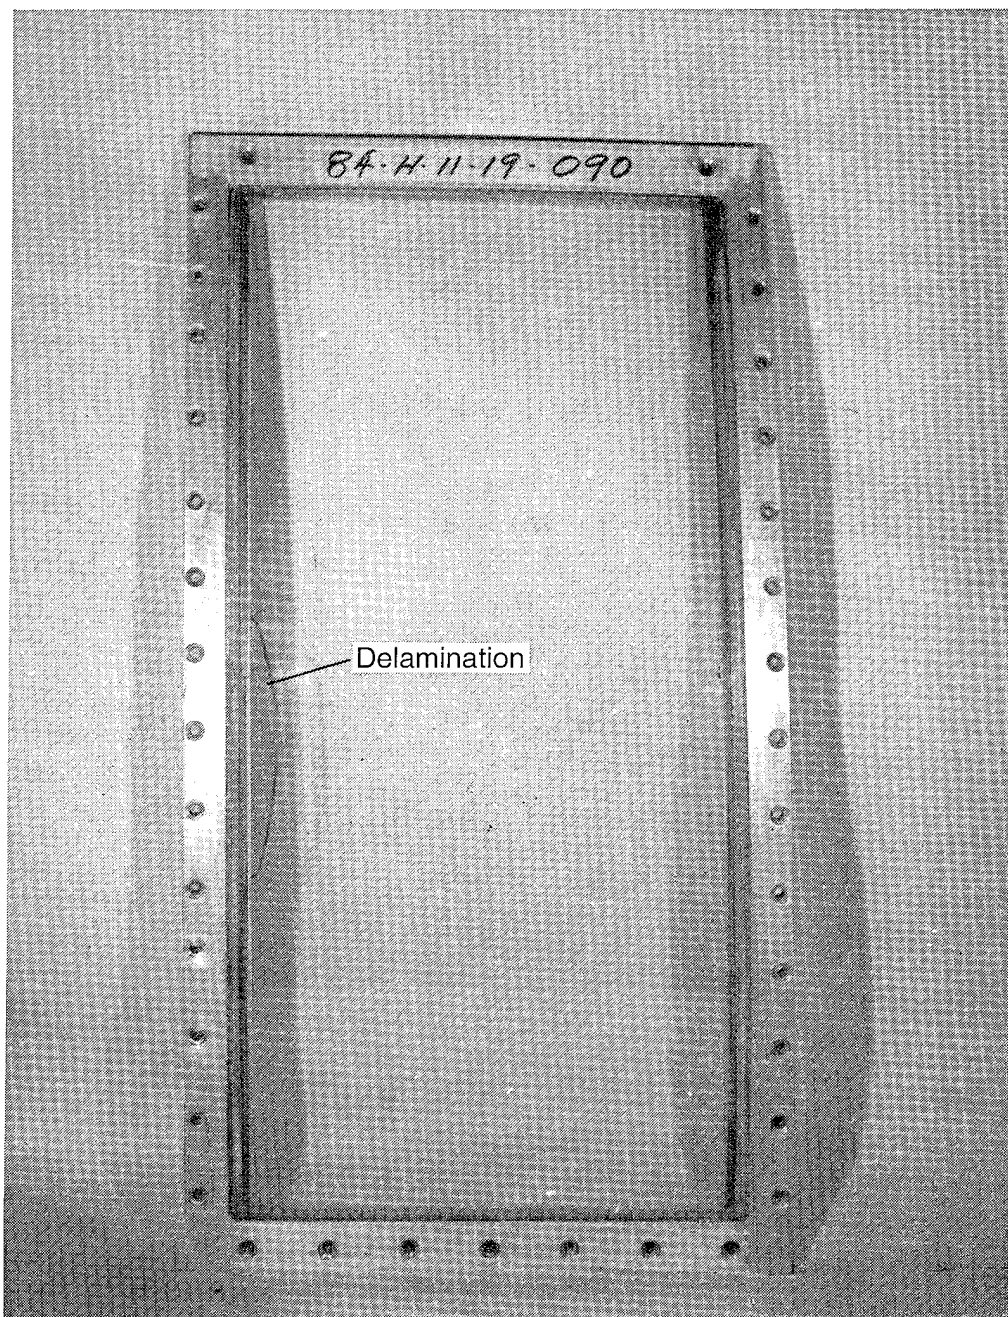
Figure 4.8 Worst B-52 Escape Hatch Delamination (S/N 84-H-11-19-090)

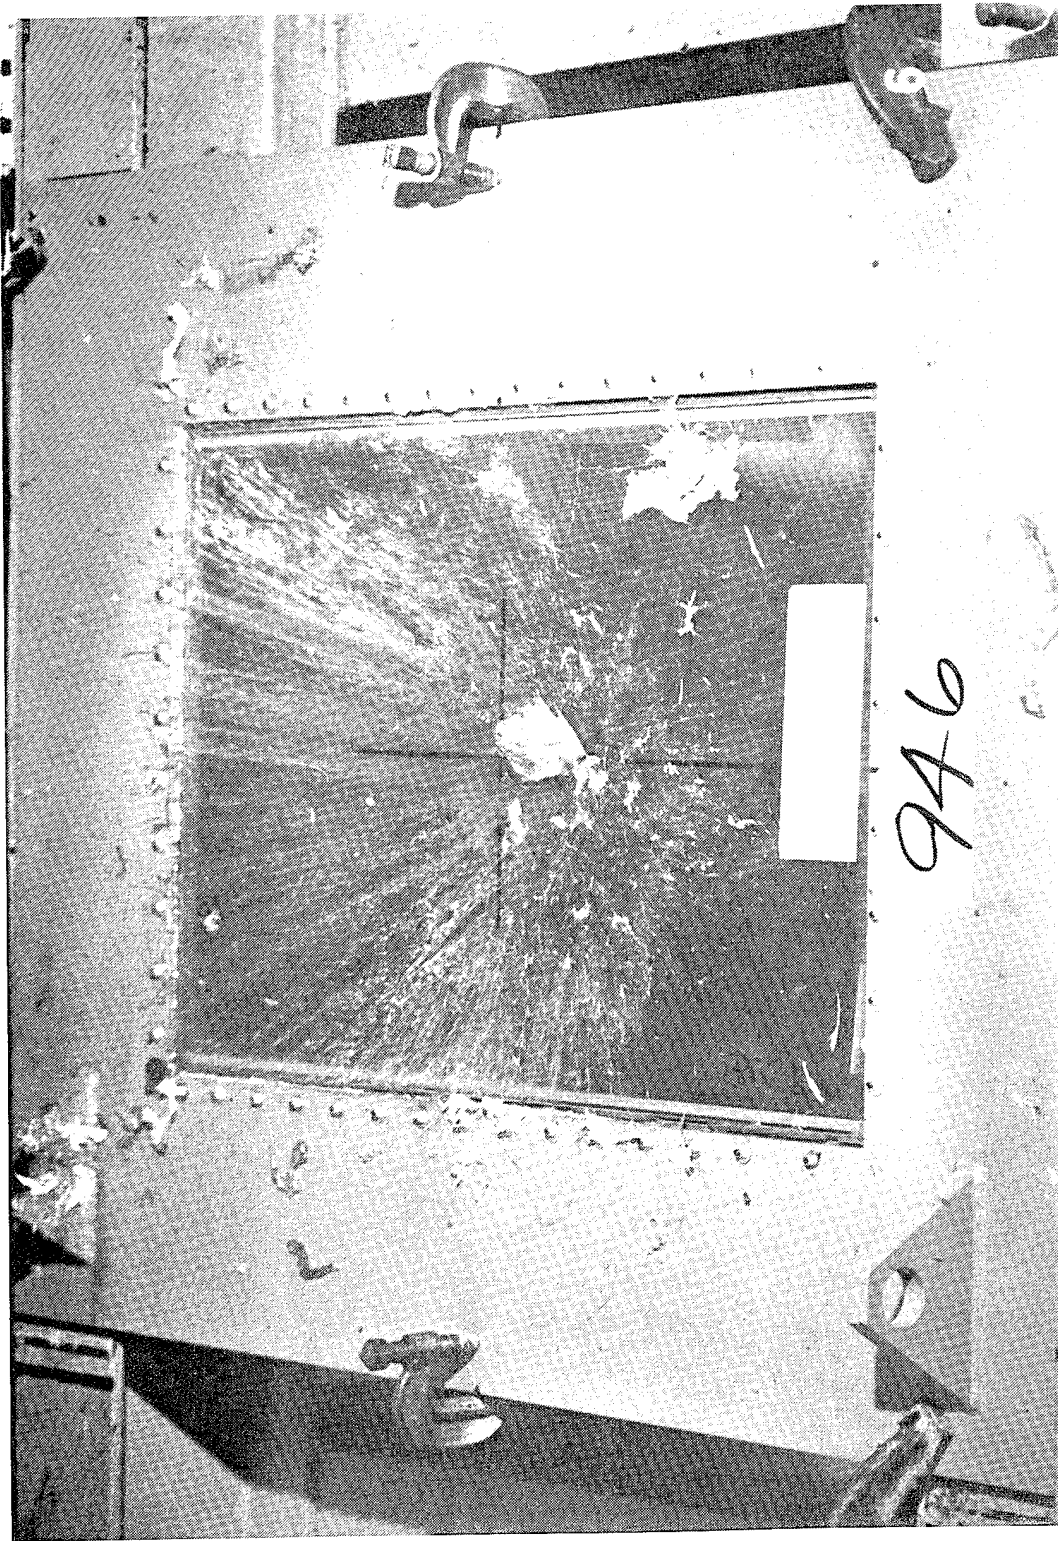
Figure 4.12 B-52 #1 W/WS Showing No Damage From a 4-Pound Bird Impact at 251 knots (S/N 87-H-11-30-749)

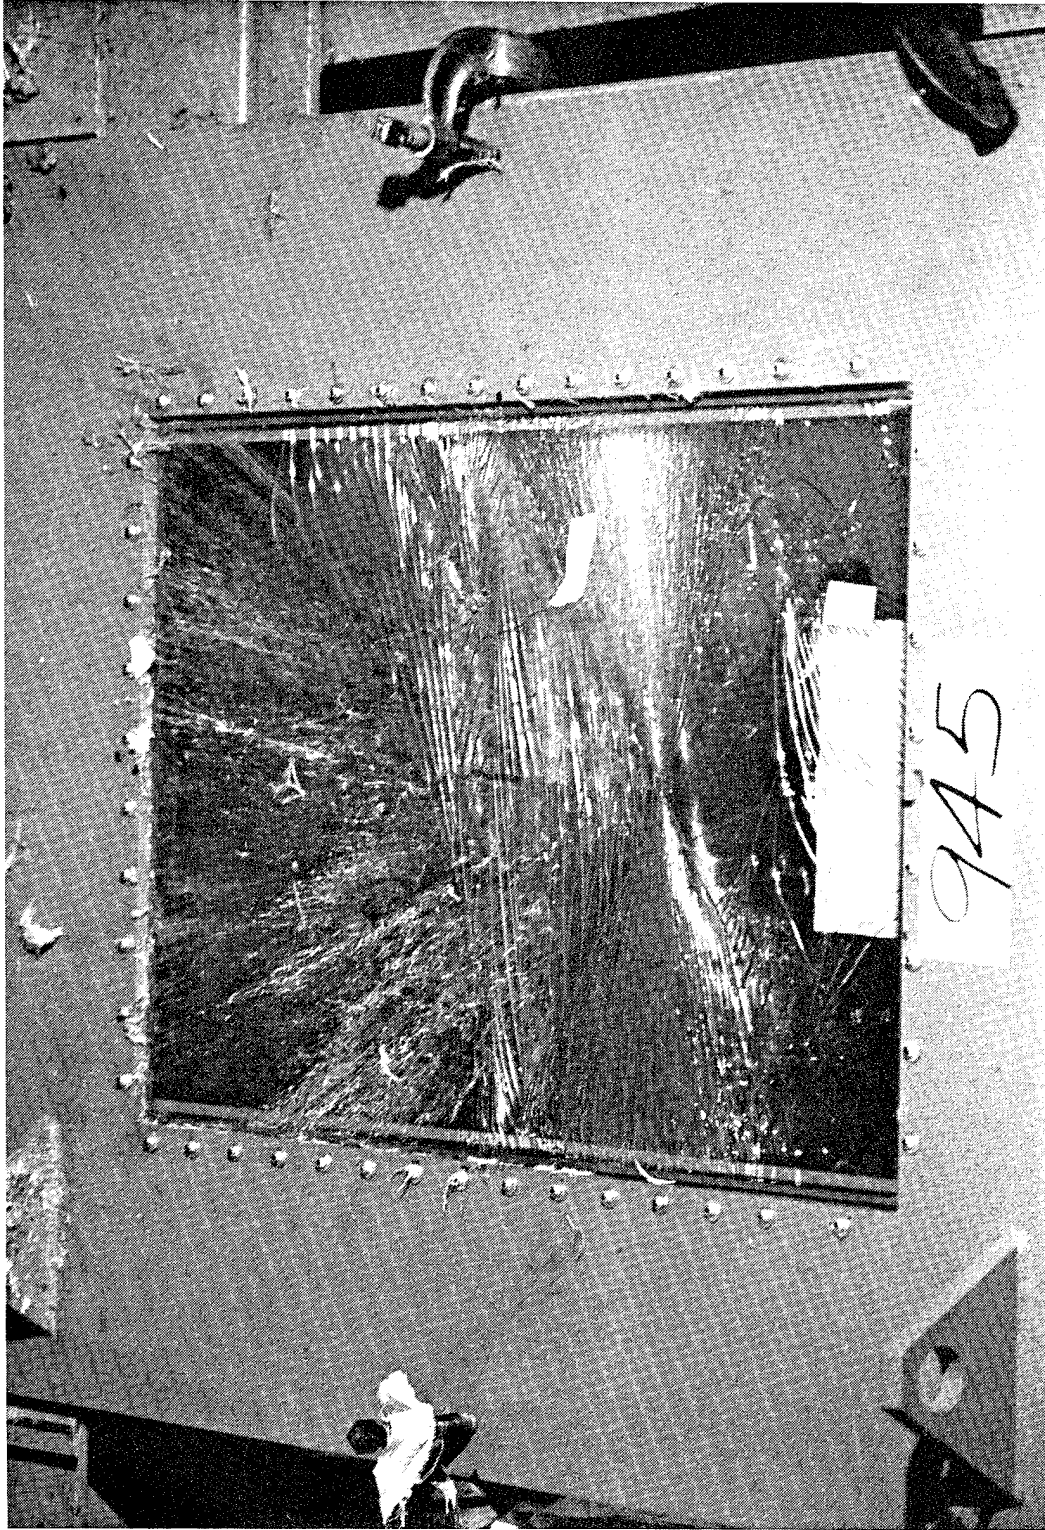
Figure 4.13 B-52 #1 W/WS Showing Outboard Ply Failure From a 4-Pound Bird Impact at 212 knots (S/N 86-H-03-03-298 )

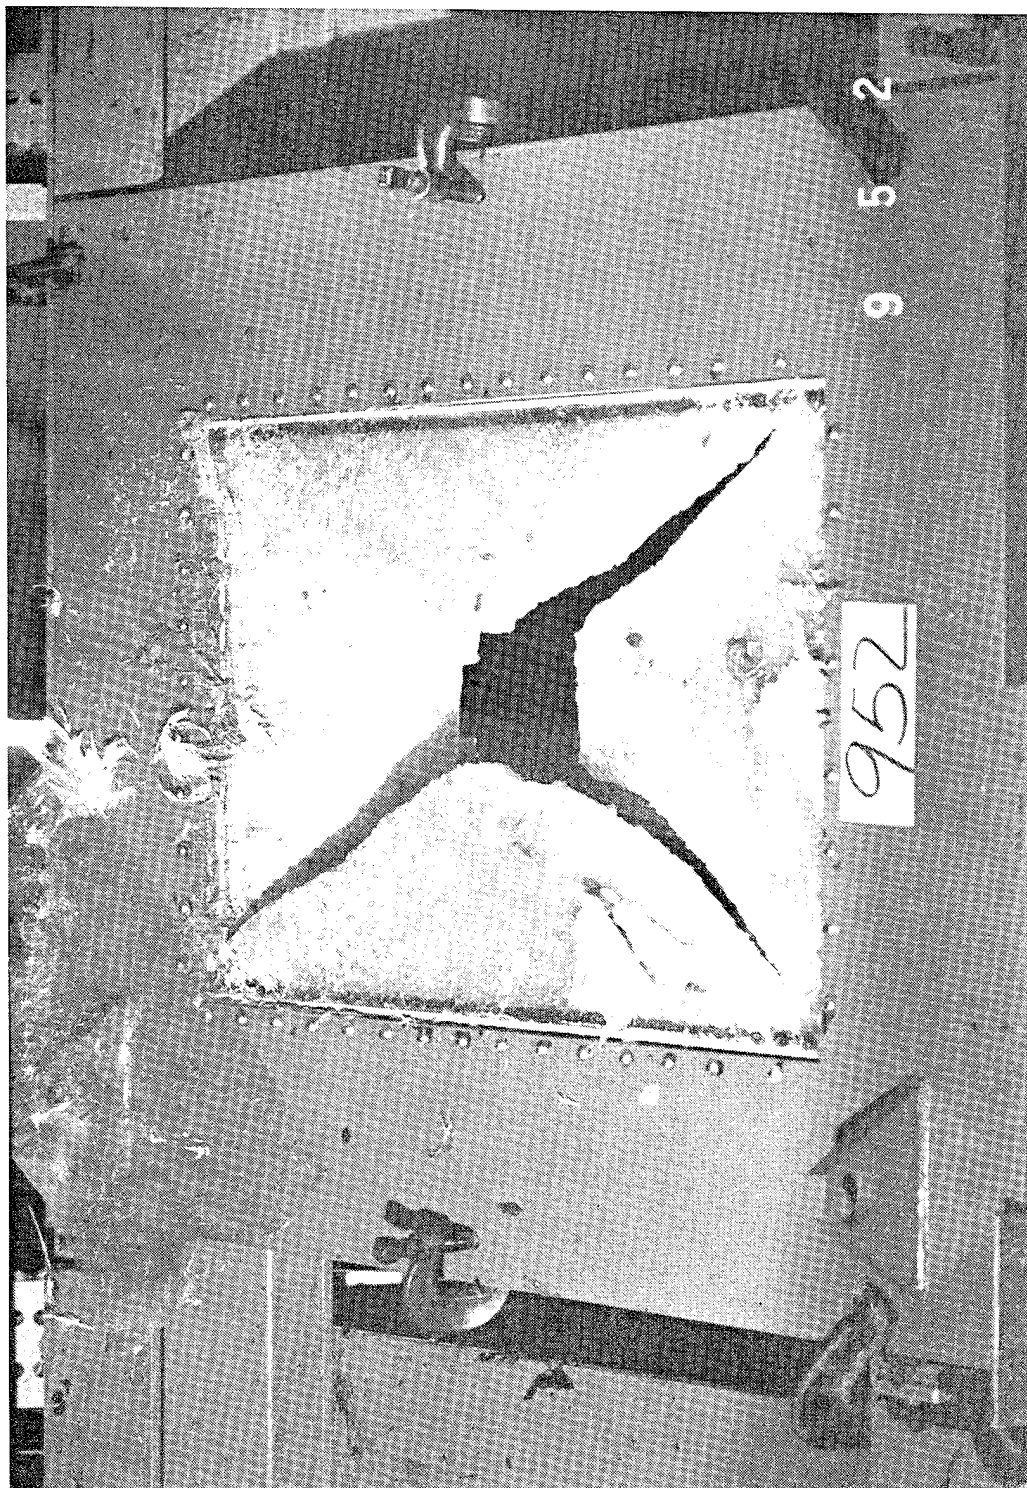
Figure 4.14 B-52 #1 W/WS Showing Worst Damage ( Complete Transparency Failure) From a 4-Pound Bird Impact at 250 knots (S/N 86-H-04-28-693 )

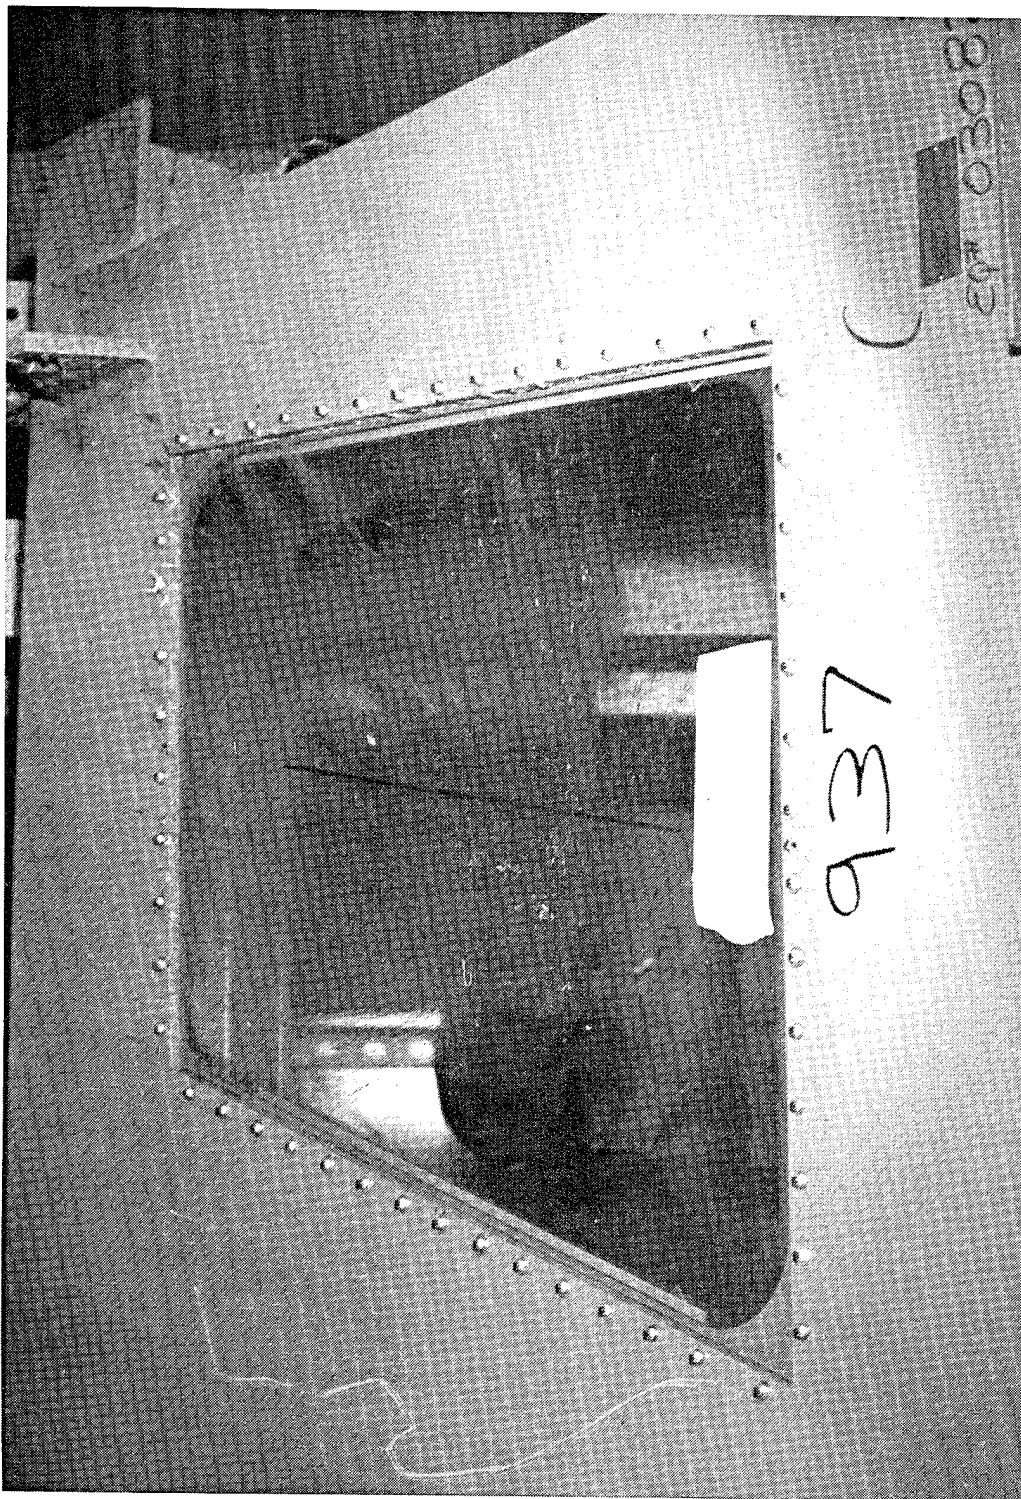
Figure 4.15 B-52 #2 W/WS Showing No Damage From a 4-Pound Bird Impact at 309 knots (S/N 92-199-HO-423)

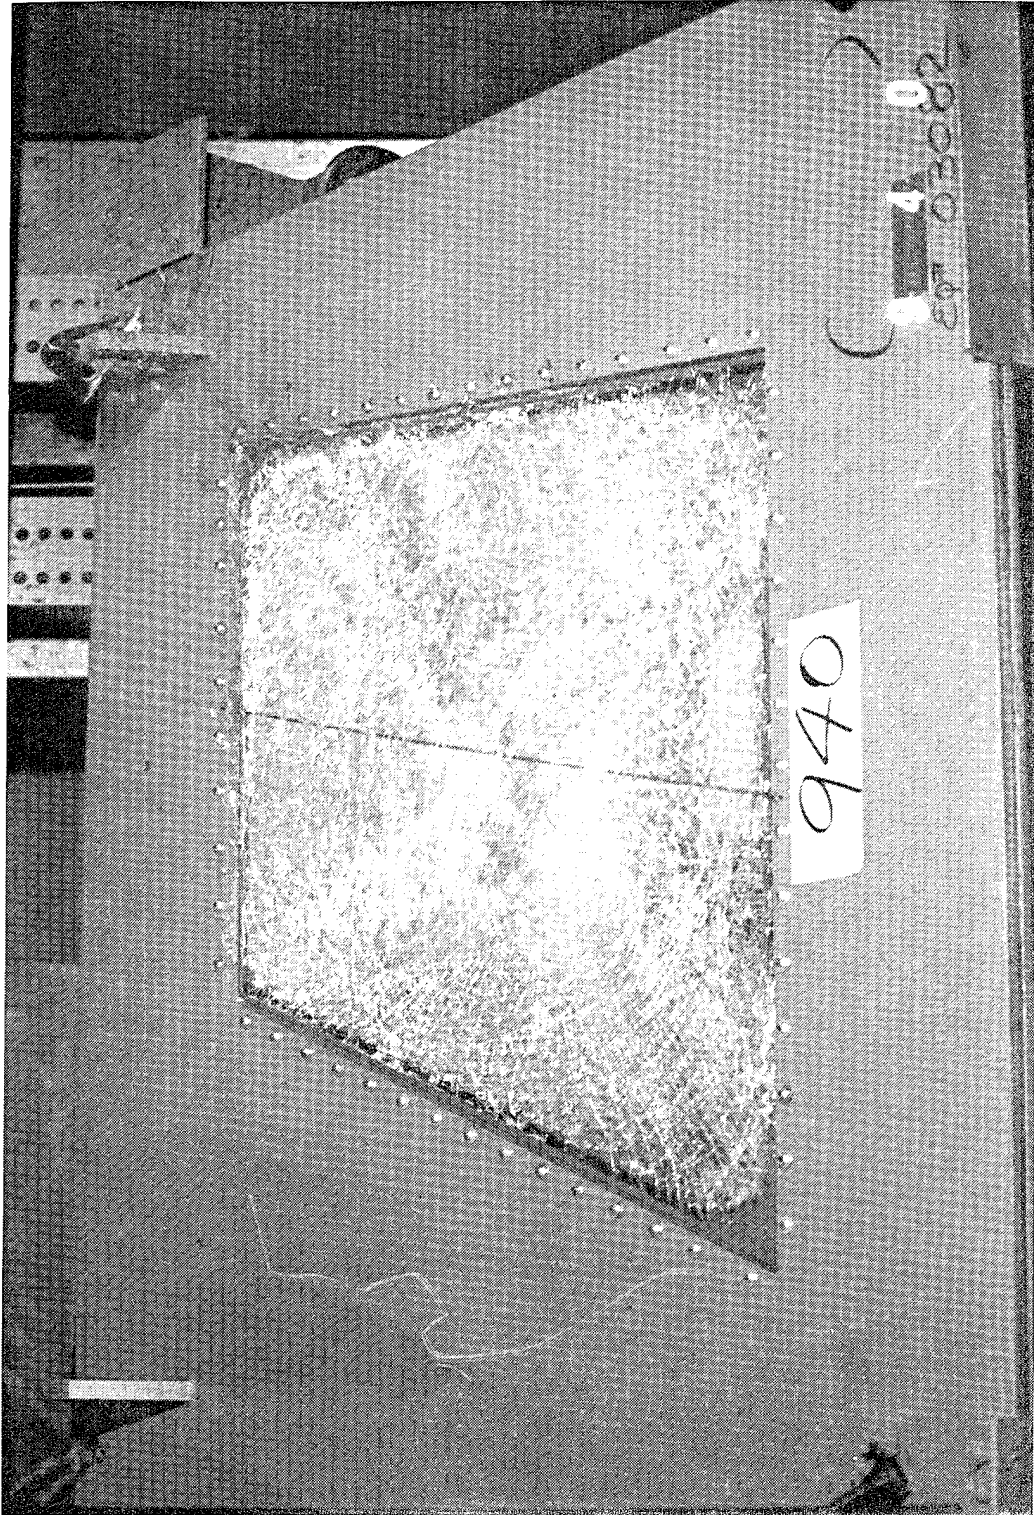
Figure 4.16 B-52 #2 W/WS Showing Outboard Ply Failure From a 4-Pound Bird Impact at 306 knots (S/N 5-H-3-04-09)

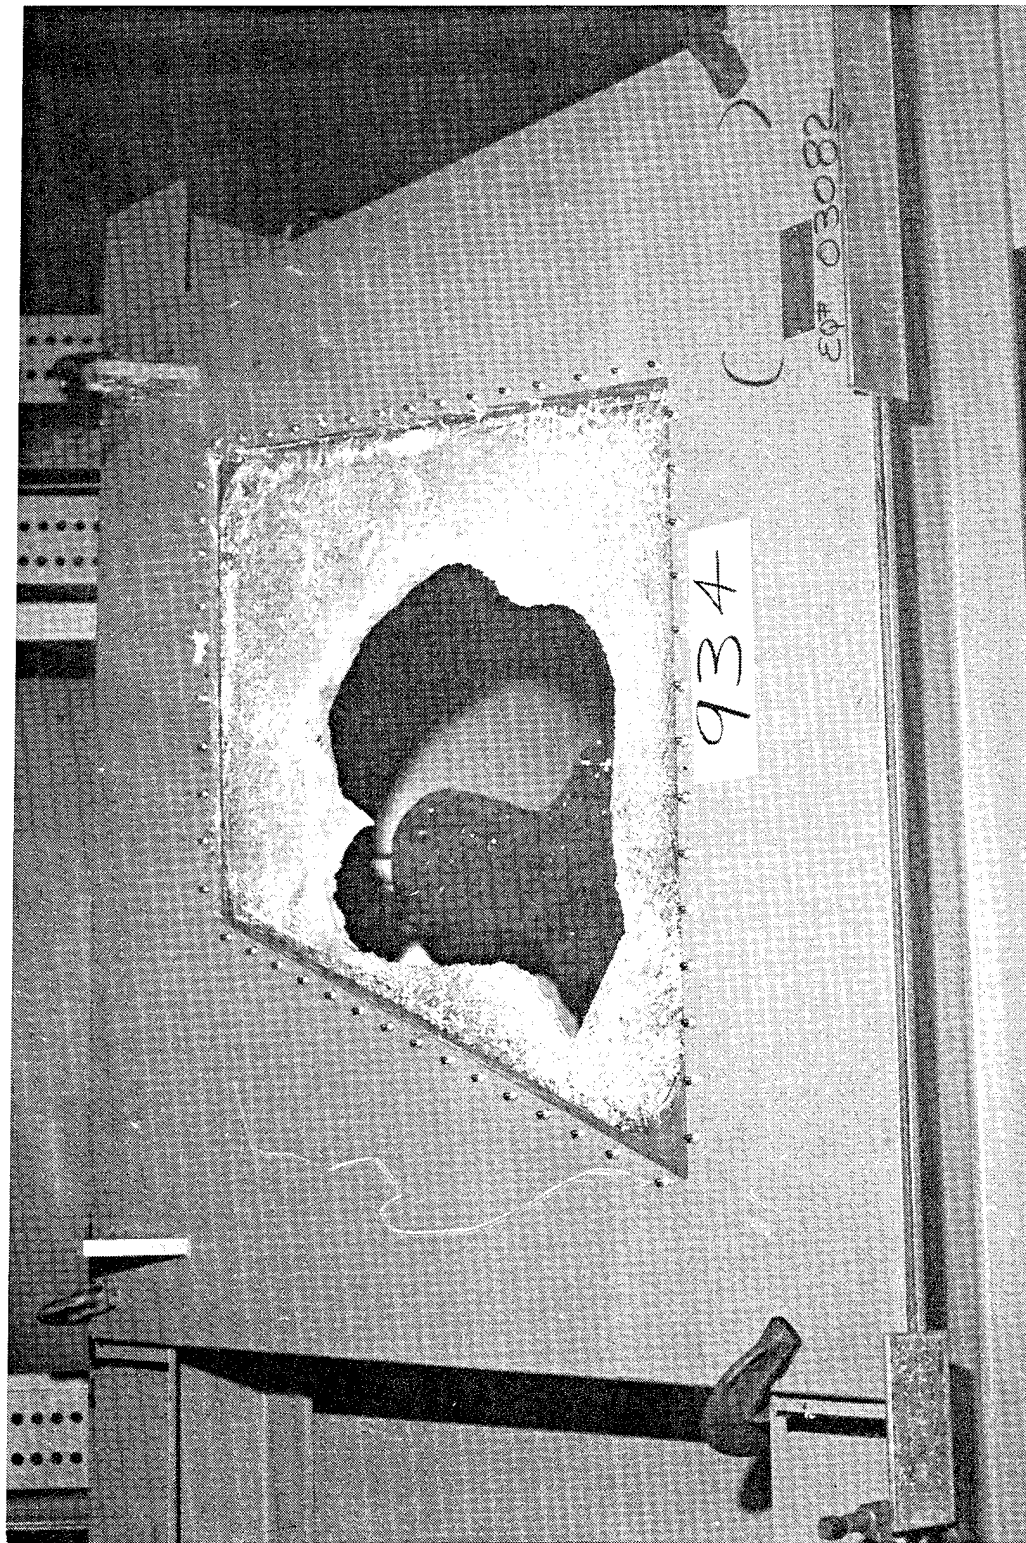
Figure 4.17 B-52 #2 W/WS Showing Worst Damage (Complete Transparency Failure) From a 4-Pound Bird Impact at 403 knots (S/N 8-H-11-20-277)
